## Anatomy of an Accident

(Sidebar to: Ensuring Spin Test Safety)

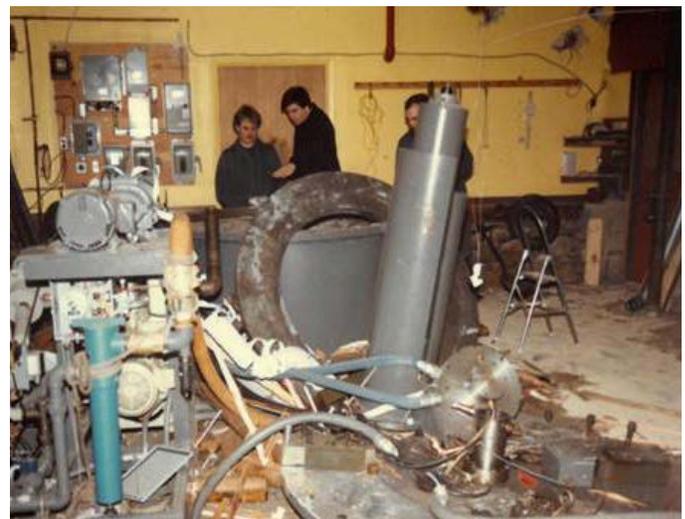
At approximately 1 A.M. on January 10 the rotor reached 14,000 rpm and burst. Three people conducting the test were located in a room adjacent to the test room and one floor above. They were above the burst plane and away from the top of the chamber, both of which are classic hazard zones. The burst made a single thud-like noise (typical of bursting rotors), and the testers approached the room to inspect the part. The corridor and stairwell were full of plaster and concrete dust and the sprinkler alarm was sounding loudly. Lead bricks from inside the spin pit were found in the hall, and soon sirens were heard outside.

The scene in the test room was one of complete devastation. The cover of the spin pit, weighing 1-1/2 tons, had been blown up through the ceiling and fallen back down. The rollup door of the test room had been blown out into the parking lot. The side of the building had extensive damage from lead bricks and pieces of the impeller penetrating the wall. One lead brick flew out the side wall, penetrated the side of a neighbor's house, and came to rest in the kitchen. Miraculously, no one was injured.

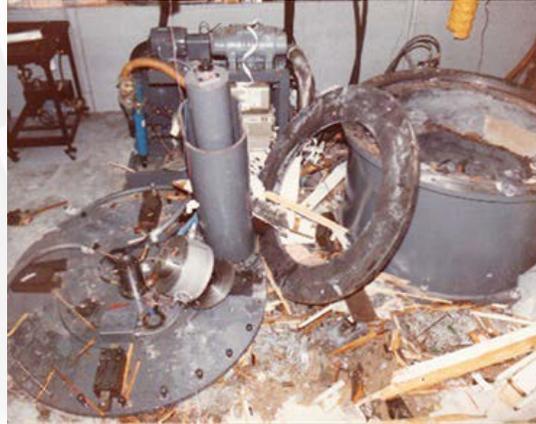
There were holes in the walls of the building on a line approximately 45 degrees up from the centerline of the pit covering an area of about 320 degrees. This ejection cone directly intersected the control room where the test engineers were located, but the area of destruction had a gap almost exactly the size of the control room (fragments had penetrated the walls within two feet of the control room).

Considerable time was spent analyzing the incident and examining the forensic evidence. The spin chamber had contained the radial burst forces, and only 5% of the kinetic energy escaped from the pit. This energy, however, was enough to cause structural damage to the steel beams that held up the building, blowout walls, and drive the spin chamber into the concrete floor of the room. The floor was pushed down about 1 inch and the three leveling pads (2 inches tall) were embedded in the concrete.

It was concluded that the cause of the accident was the impact of impeller fragments on the lead wall inside the chamber, extruding the lead bricks vertically and exerting a force on the cover of the spin pit of approximately 2.1 million pounds. The cover bolting arrangement used 24 each of 1 inch bolts and nuts with a combined strength of 1.9 million pounds. Some of the high-strength bolts were broken in the tensile mode but most of them remained intact. However, the threads were stripped out of the nuts and some damage to the bolt threads occurred. After an analysis, it was determined that the bolts were able to develop approximately 80% of their rated holding power. There was no evidence of chemical explosion, no fire, and no excess heat.

A one-fifth scale model of the spin pit and rotor was built, put inside another spin pit, and burst to verify the failure theory. A ledge was then designed and welded onto the pit liner. This ledge was designed to turn the lead bricks back inside the pit and contain the extrusion. This procedure confirmed that the ledge in the liner would contain the extrusion forces.

A new full-size spin test system was built, with the new ledges installed, and tested at the customer's site with the same type of rotor and in the same conditions under which the accident had occurred. The spin pit was placed inside a reinforced concrete test room for safety. The test was successful, and the burst was contained exactly as predicted by the model pit experiment.
